A DEFENSIBLE COMMUNITY?

A Retrospective Study of
Montecito Fire Protection
District's Wildland Fire
Program during the 2017
Thomas Fire

October 9, 2018

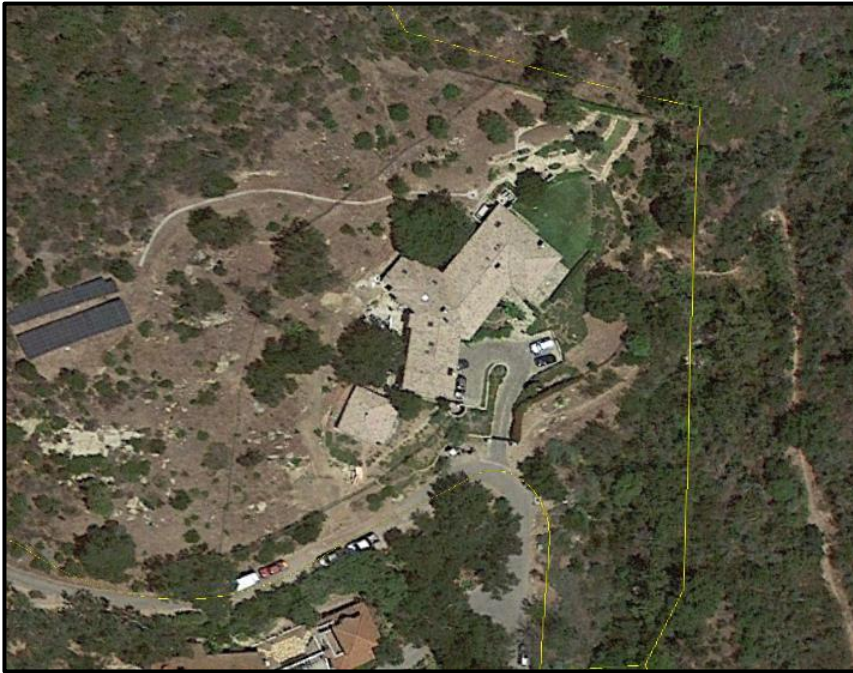
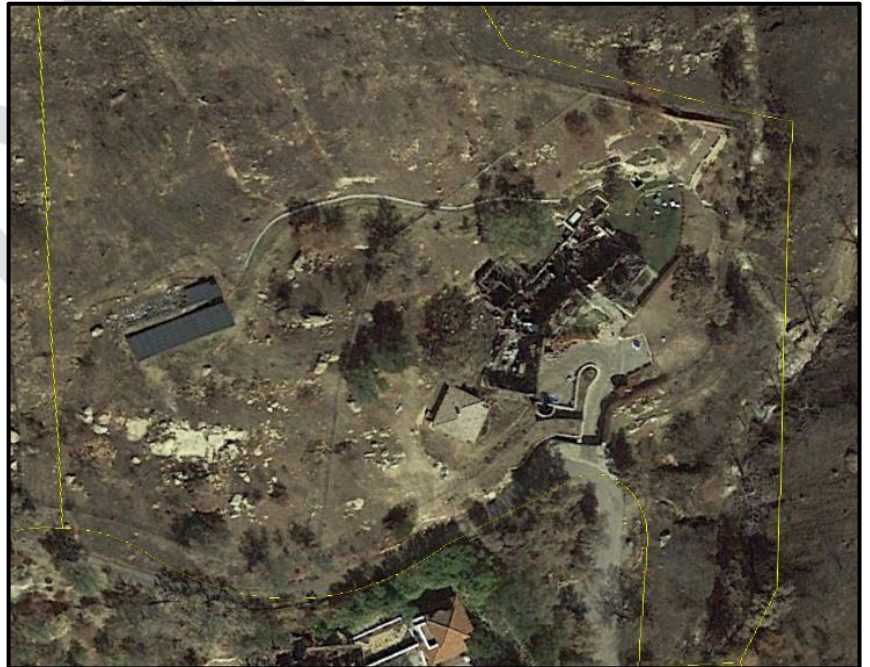
The PDU sits next to a steep draw with dense fuels pre-Thomas Fire (see images below). An interviewee indicated that the fire moved down into this draw and generated substantial fire intensity in the heavy fuels. Several interviewees stated that Park Hill Lane was not a road where they felt safe conducting firefighting operations. Park Hill Lane is a narrow, winding dead end street that lacked an adequate turn around area for fire apparatus at its upper end. It is likely this PDU had either direct flame impingement from the vegetation on the east side or ember impingement on the east side. The property-owner could not improve defensible space to the east due to a riparian area (See following page for images).

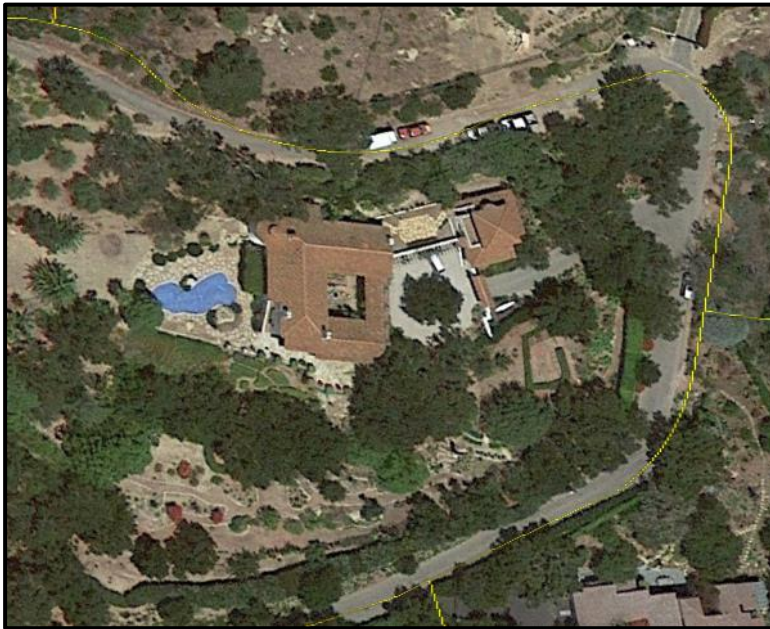
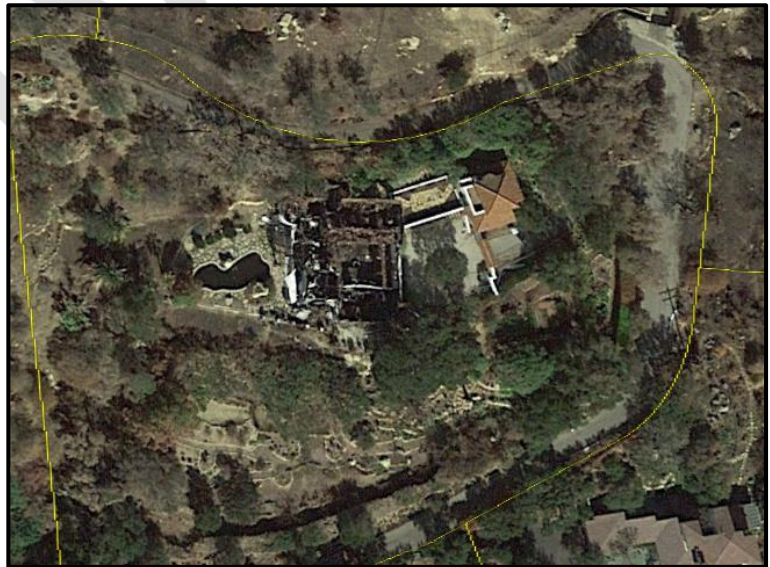
Park Hill Lane – This PDU was built in 1965 and was built with non-combustible roof and siding material and had dual-pane windows. There was considerable green vegetation around the PDU pre-fire with imagery showing that this vegetation was immediately adjacent to the PDU. No evidence of hazard reduction clearing is discernable from the imagery. This location is a candidate for ember ignition as the source of its damage. Firefighters were unable to conduct fire following structure defense operations due to unsafe nature of Park Hill Lane.

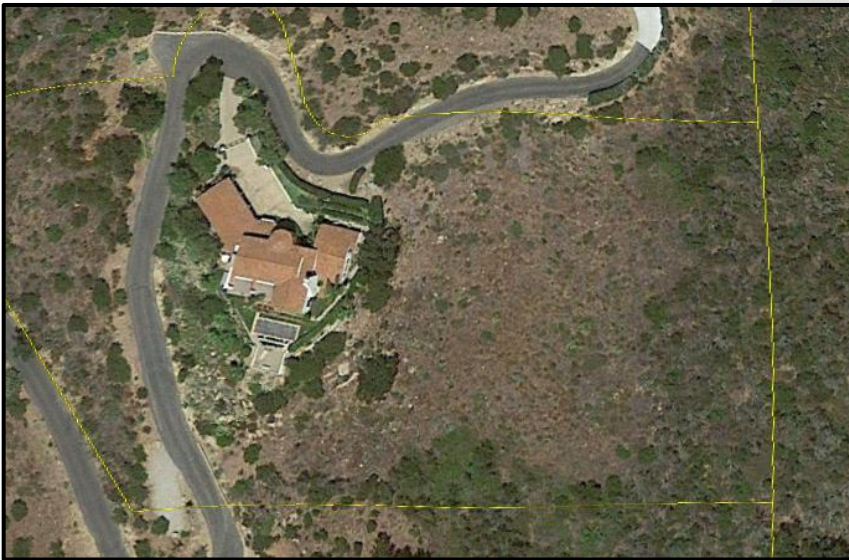
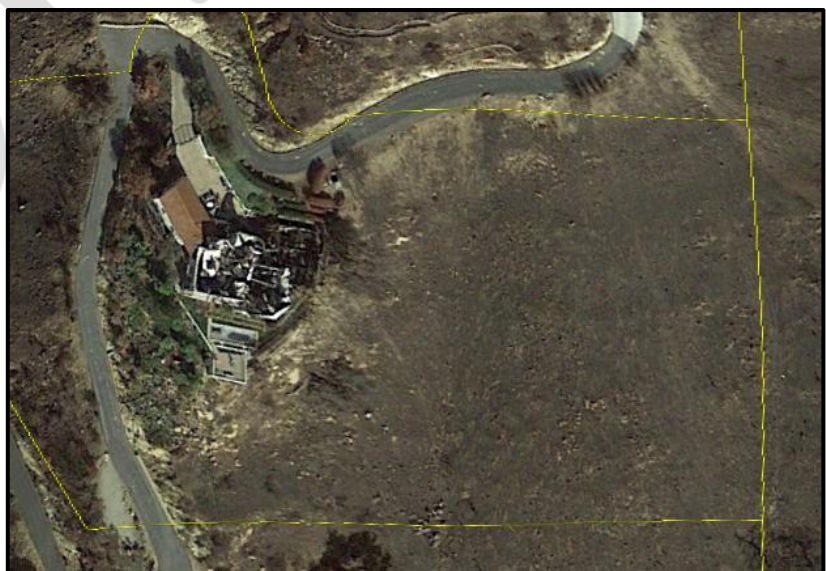
Park Lane – Built in 1998, the PDU was destroyed in the fire. No information on the type of construction material used at this property is available. Interviewees indicated that the backing fire affected this location, so it is unlikely that severe fire behavior contributed to the loss of the PDU. The property-owner had cleared substantial vegetation on all sides of the structure, up to about 60m (200 feet) on the downhill/east side; however, substantial green vegetation was retained directly adjacent to the PDU. This structure most potentially ignited from ember cast, and firefighters speculate that the property-owners likely left a window or garage door open allowing embers to enter the structure. The vegetation on the west side of the PDU did not burn and remained green while it appears that the vegetation on the east side of the structure burned due to the structure burning. The PDU was located toward the end of a long, narrow drive and lacked an adequate turn around for fire apparatus.

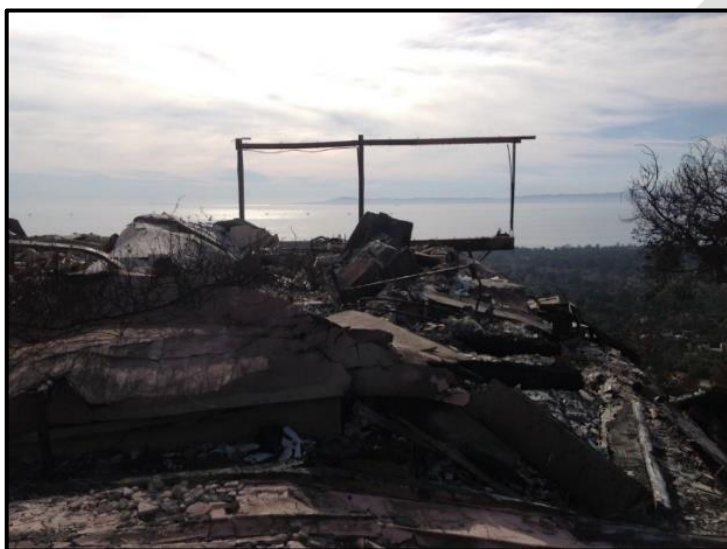
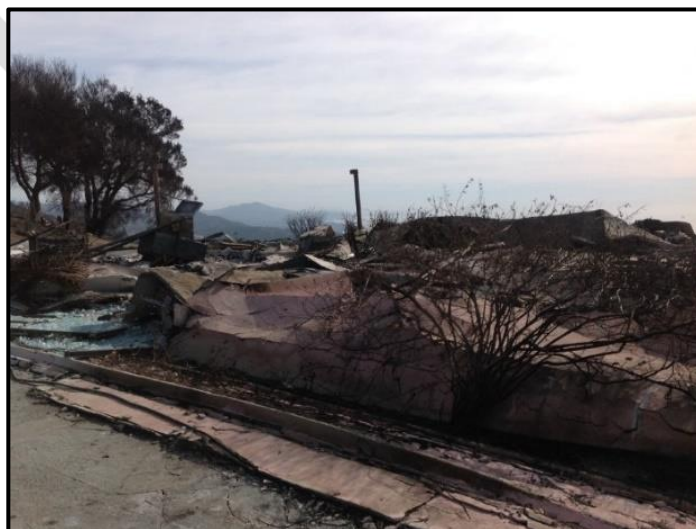
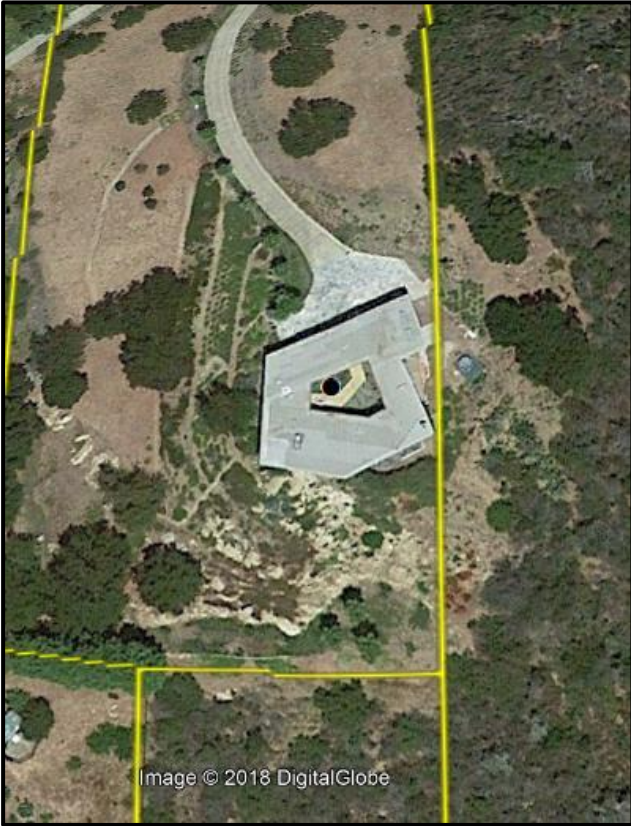
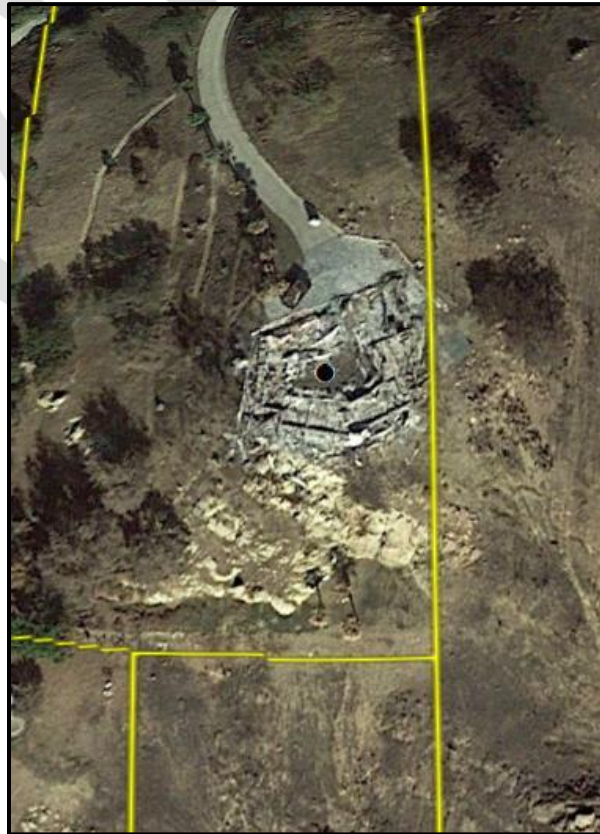
Hot Springs Lane – Built in 1984, the PDU was destroyed. No information on construction materials is available. The PDU was located at the end of a long and winding driveway that lacked an adequate turnaround for fire apparatus. Property-owners had cleared substantial vegetation away from the structure, approximately 30m (98 feet) on three sides (north, west, and south) but only 5-10m (16-33 feet) on the east side due to property line constraints. Aerial imagery indicates that the pentagon shaped structure had a courtyard in the center of the building. In the aerial photo, vegetation is visible within the courtyard. Much of the cleared area around the structure had been type converted to grass with several large trees/shrubs retained, including some vegetation immediately adjacent to the structure. The high fuel density immediately adjacent to the east could have produced considerable fire intensity and ember cast. Two scenarios are probable regarding the destruction of this structure; ignition occurred in the courtyard from embers or the ignition of the structure is a result of fire in the vegetation immediately adjacent to the east of the PDU.

Hot Springs Lane - PDU destroyed

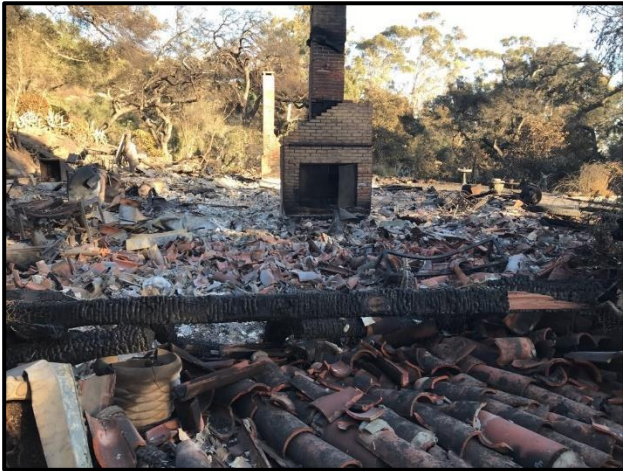
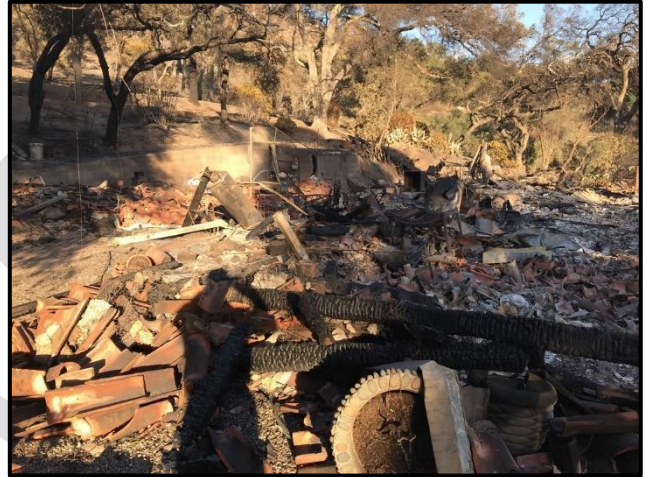
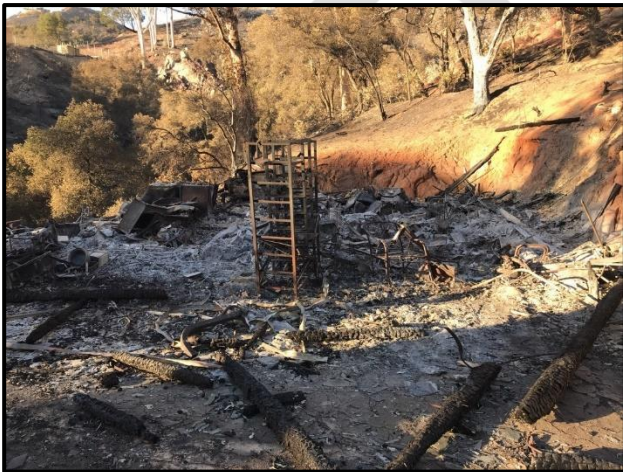
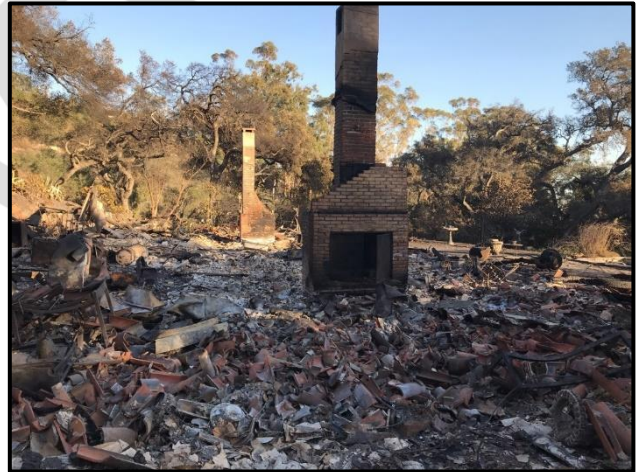
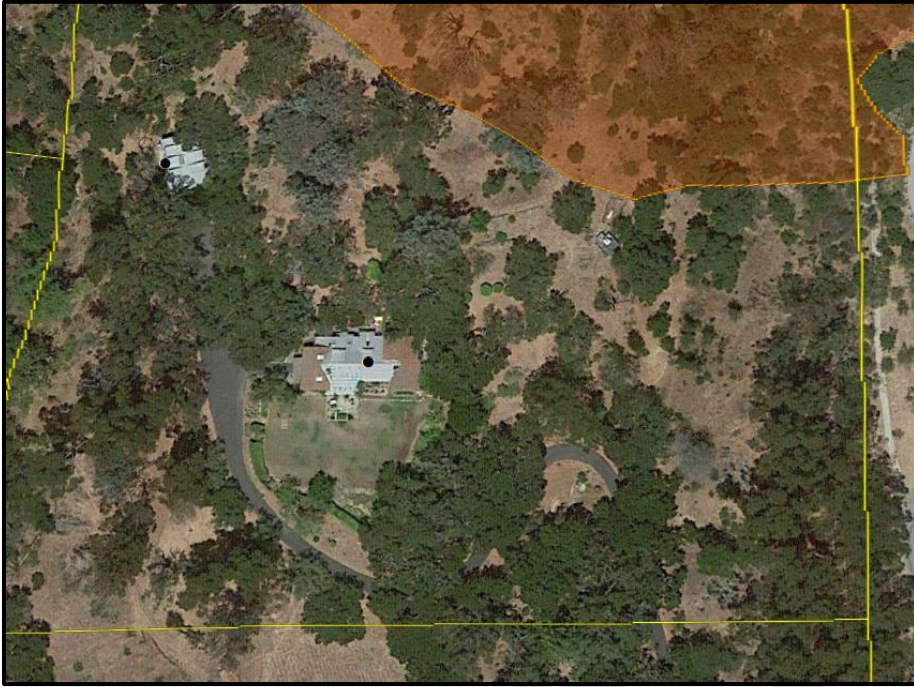
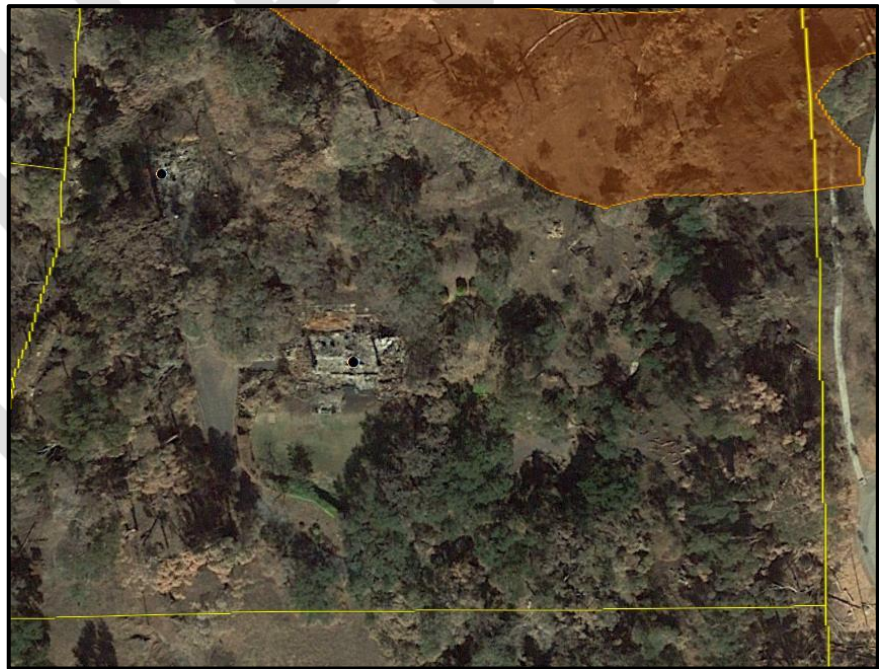
East Mountain Drive – Both the PDU and ADU were destroyed. Built in 1902, the PDU was primarily wood construction with a Spanish tile roof. The property had extensive fuels reduction done upslope of PDU pre-fire; however, there was considerable vegetation remaining immediately adjacent to PDU. Many trees around the PDU and ADU survived the fire, suggesting ember ignition in building materials. The property-owner indicated that there was substantial debris around the structures, which was currently being used as a rental property. The property had poor access and no turnarounds for fire apparatus.

East Mountain Drive – PDU and ADU destroyed

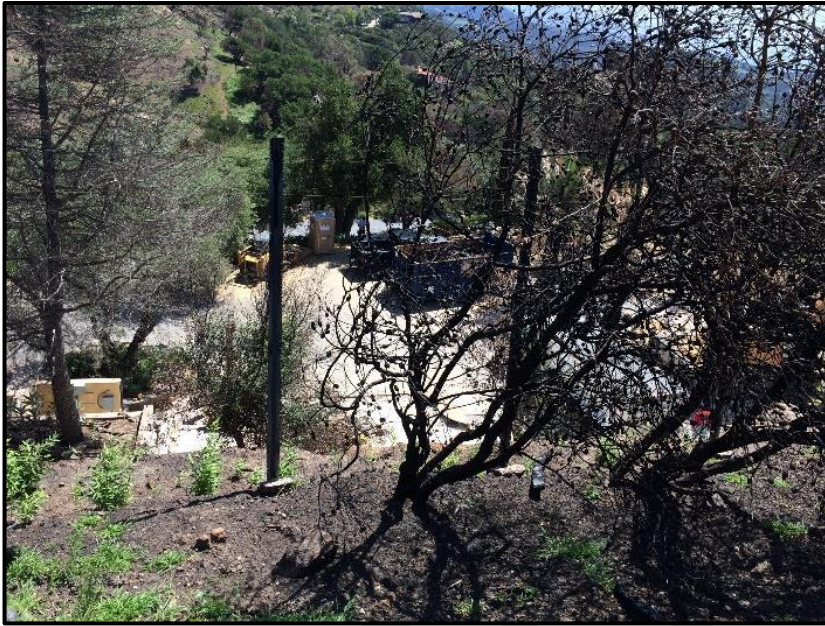
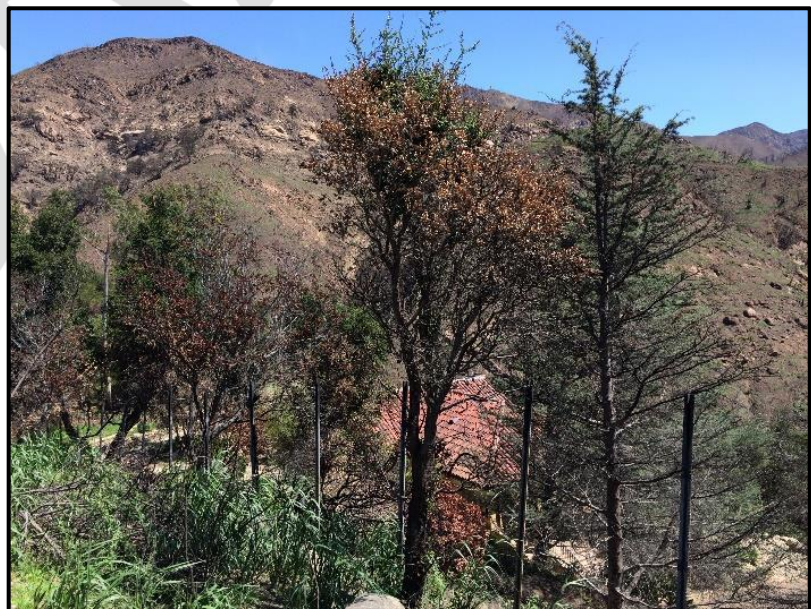
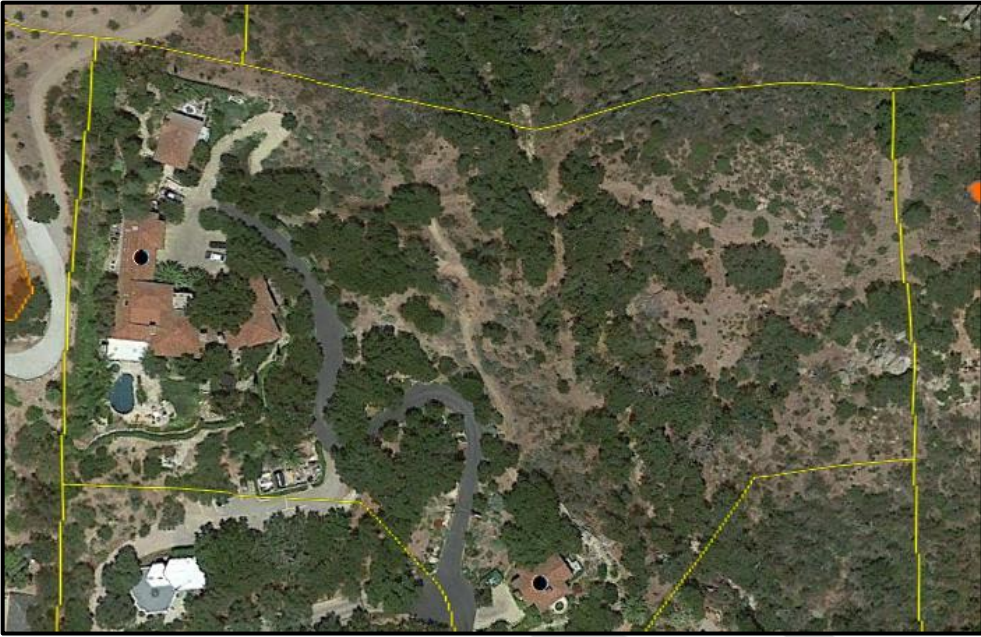
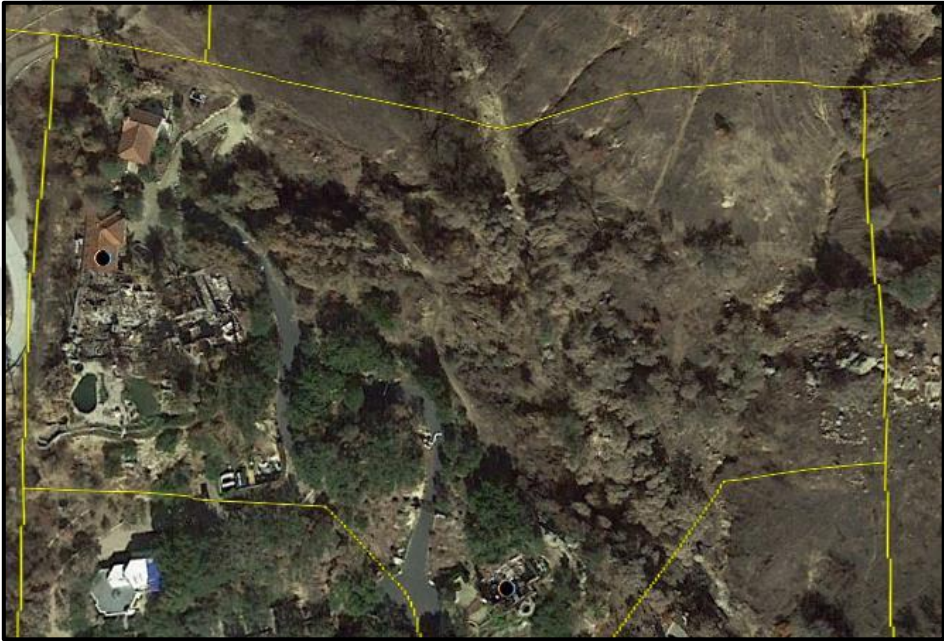
East Mountain Drive – Built in 1993 of unknown materials, both the PDU and ADU were destroyed. Based on visual assessment, the structures had Spanish tile roof. This property had been identified by District staff as a structure at risk as geographically; it straddled a drainage and was in close proximity of untreated fuel along the north edge of Montecito. Some fuel treatment had been occurred pre-fire in the vicinity of an old trail; however, considerable vegetation remained before the fire with little discernable defensible space. The property also had poor road access with no turn around location for fire apparatus.

East Mountain Drive – PDU and ADU were destroyed

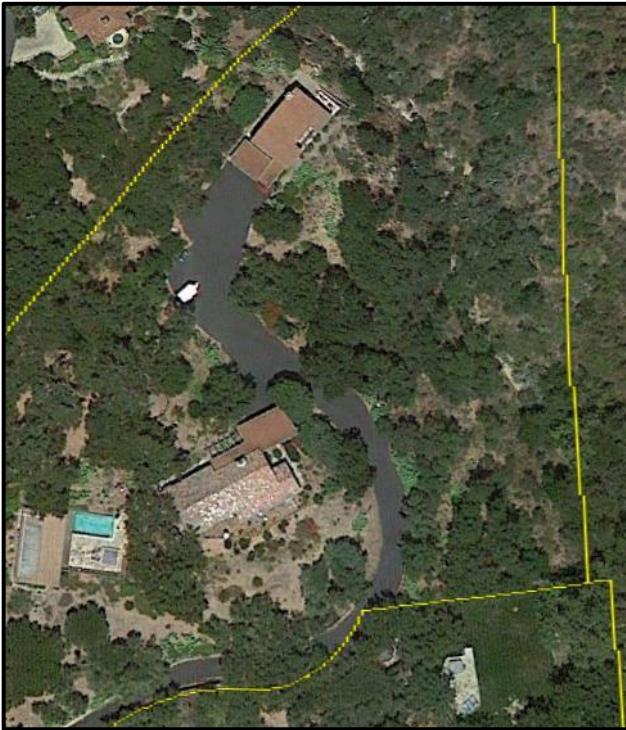
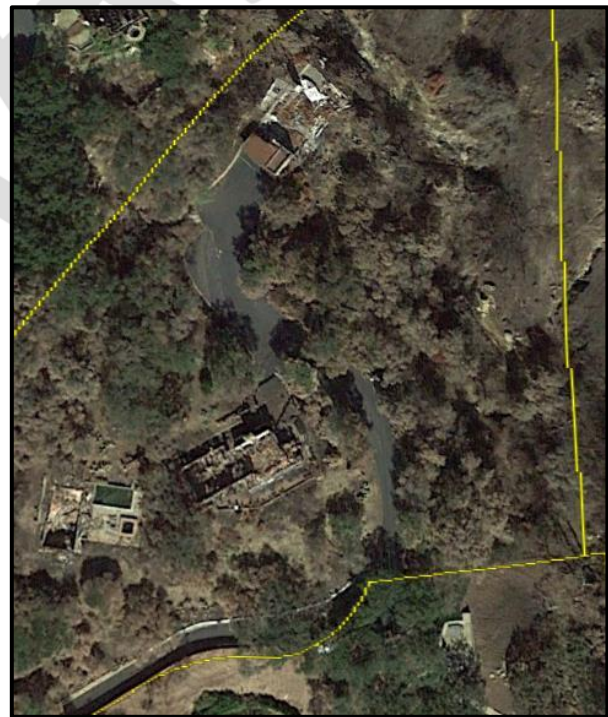
East Mountain Drive – Both the PDU and ADU were destroyed. The original structure built in 1984, did not show evidence of having been updated since the original construction. Prior to the fire, heavy vegetation surrounded both structures with no evidence of defensible space. Topographically, the structures were located on a bench above an adjacent drainage. Significant tree scorch and tree mortality is evident in the post fire imagery. This suggests that direct flame impingement from an intense surface fire combined with poor access for fire apparatus likely lead to the loss of the PDU and ADU.

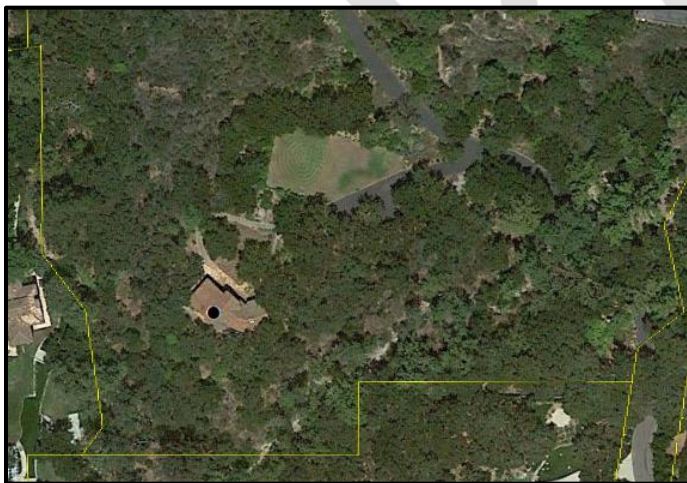
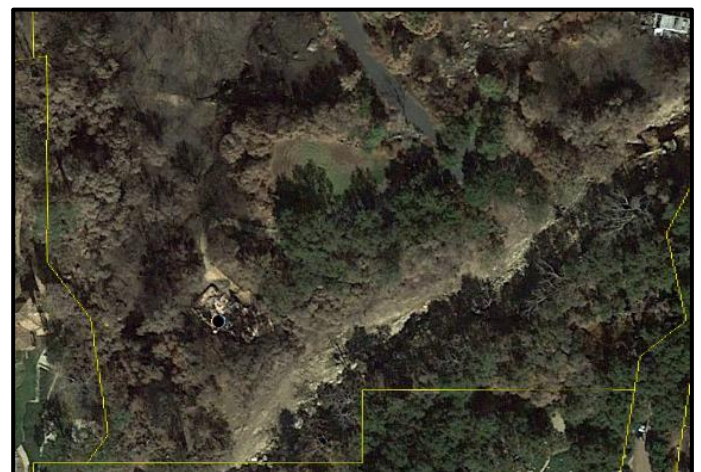
Hot Springs Road – The PDU was undamaged by the Thomas Fire while the ADU (guest house) was destroyed. Interviewees also noted that a bridge and a pump house were destroyed by the fire. Imagery indicates little or no defensible space around the ADU with heavy fuels located in the drainage below the structures. Evidence suggests a high intensity fire developed adjacent to ADU as the vegetation was completely consumed in the fire. Visual evidence suggests that direct flame impingement teamed with poor access and no turnaround areas for fire apparatus contributed to the destruction of this ADU.

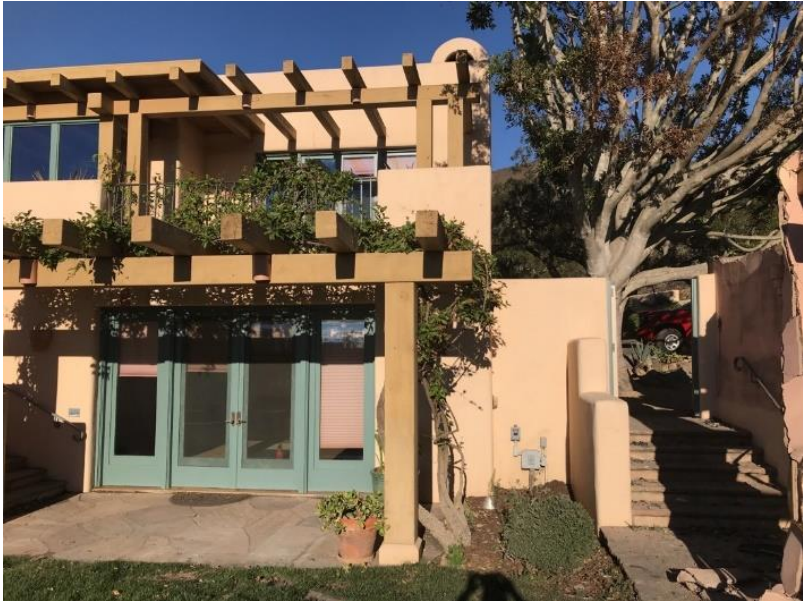
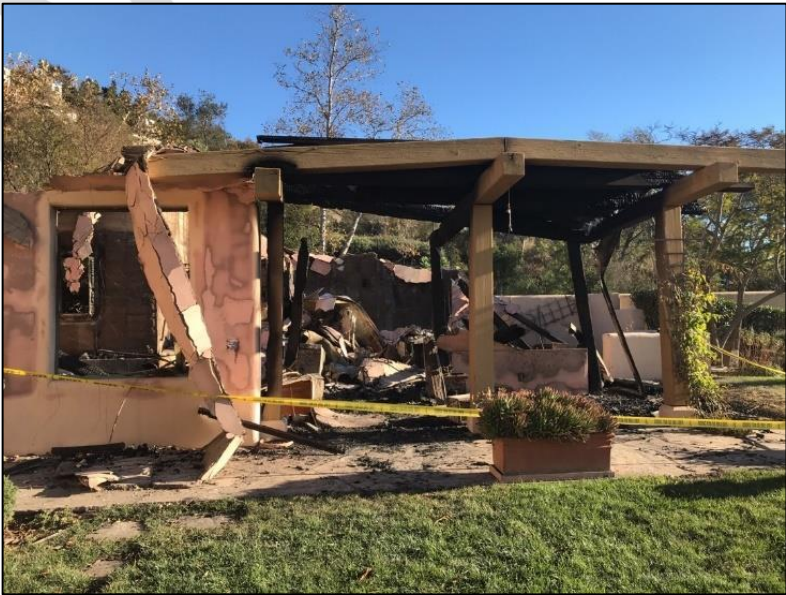
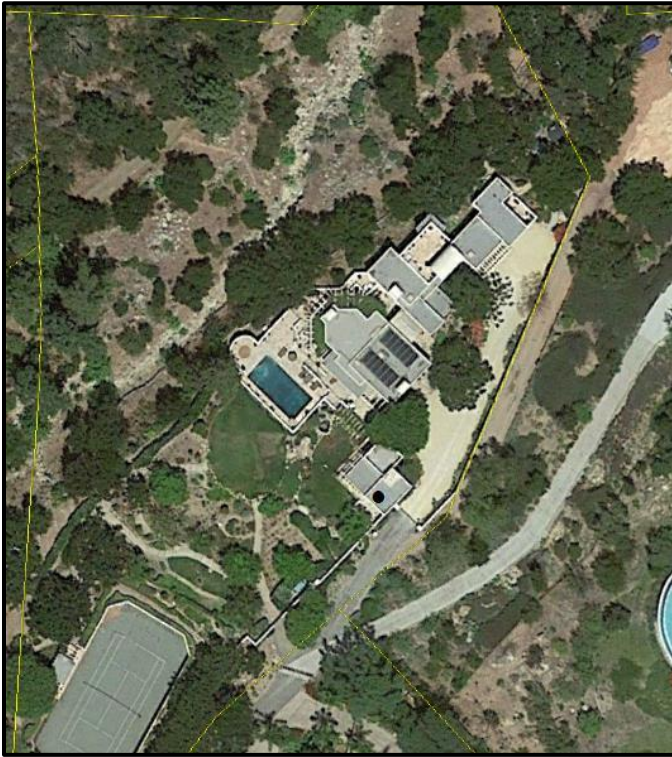
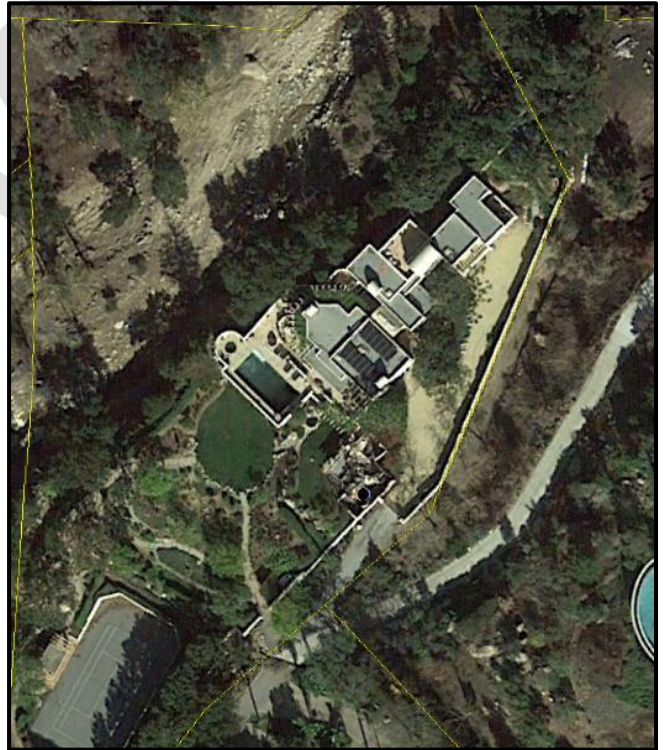
Hot Springs Lane – Built in 1989, the PDU was undamaged in the fire while the attached pool house was destroyed. Construction material consisted of a non-combustible siding and roof and dual-pane windows. The structure did have flammable structural component attached. Some defensible space is identifiable on the southwest side of the ADU, and it appears that the property-owner had thinned the brush up to the property line on the northwest side of the property. Considerable vegetation (shrubs and trees) remained immediately adjacent to the ADU but most vegetation adjacent to the destroyed structure was green after the fire suggesting that this was an ember ignition.

Hot Springs Lane - ADU was destroyed but the PDU survived

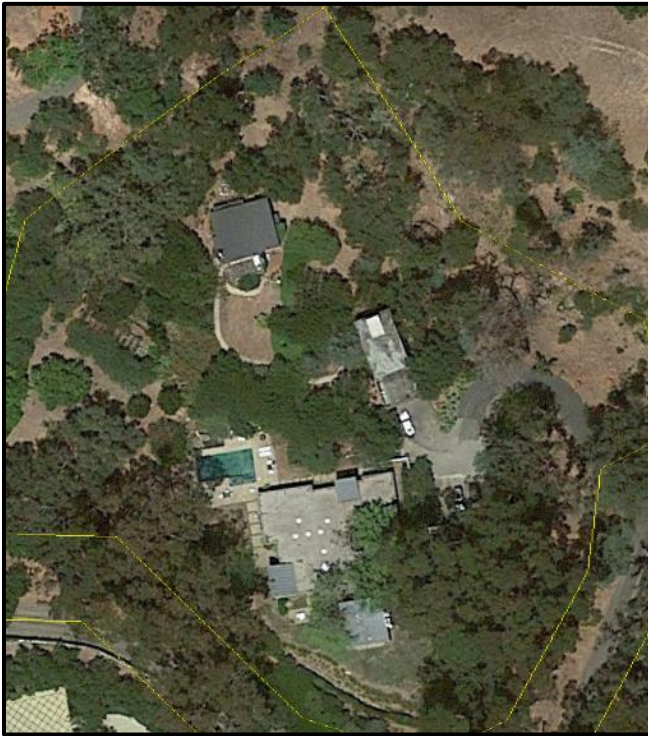
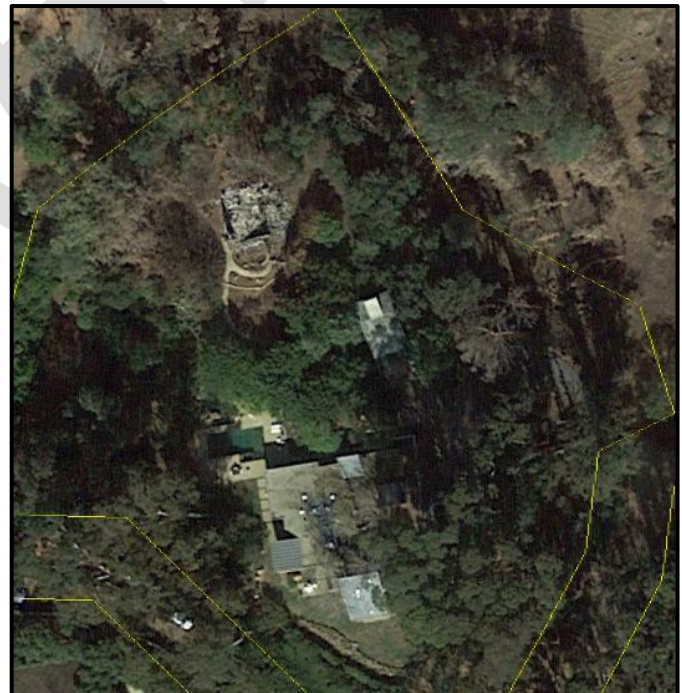
East Mountain Drive – The ADU was destroyed while no damage occurred to the PDU. Parcel data indicates the ADU was built in 1974 (likely had been a PDU). Immediately adjacent to the Thomas Fire perimeter, the fire was stopped between the ADU and PDU. Pre-fire imagery indicates that there was no defensible space, with an approximately 80% cover of dense vegetation around the ADU and PDU and on the property as a whole. This vegetative cover included mature oak and eucalyptus trees. The amount of green vegetation associated with this property post-fire suggests either ember ignition or impingement of the flaming front.

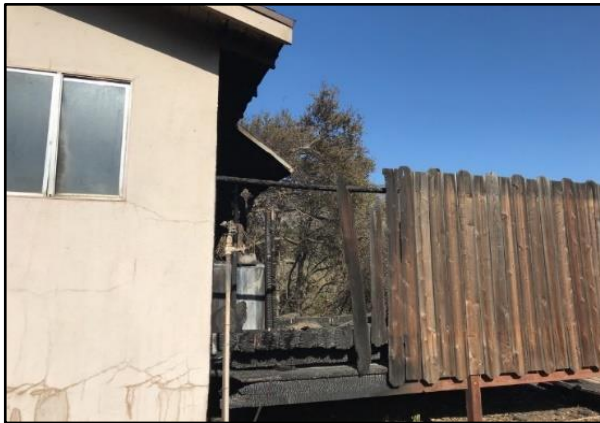
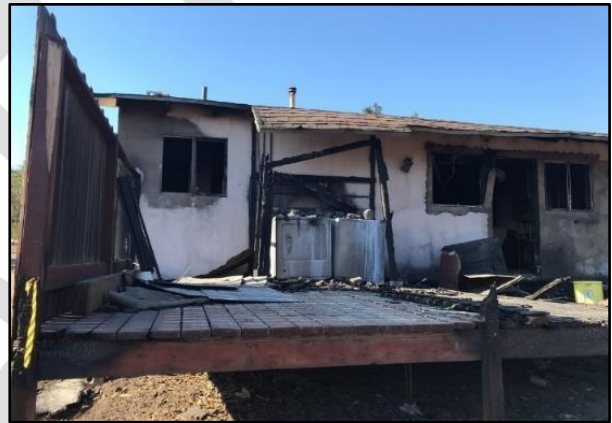
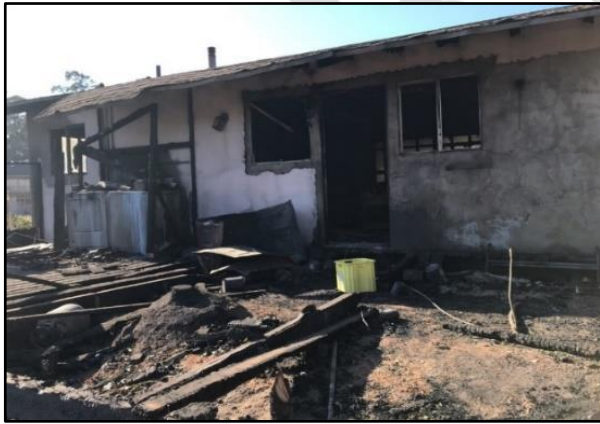
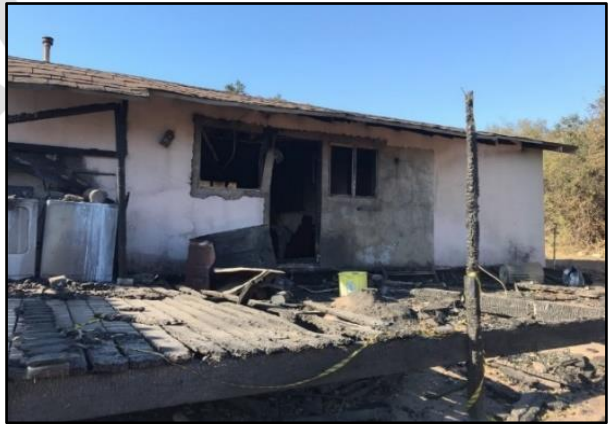
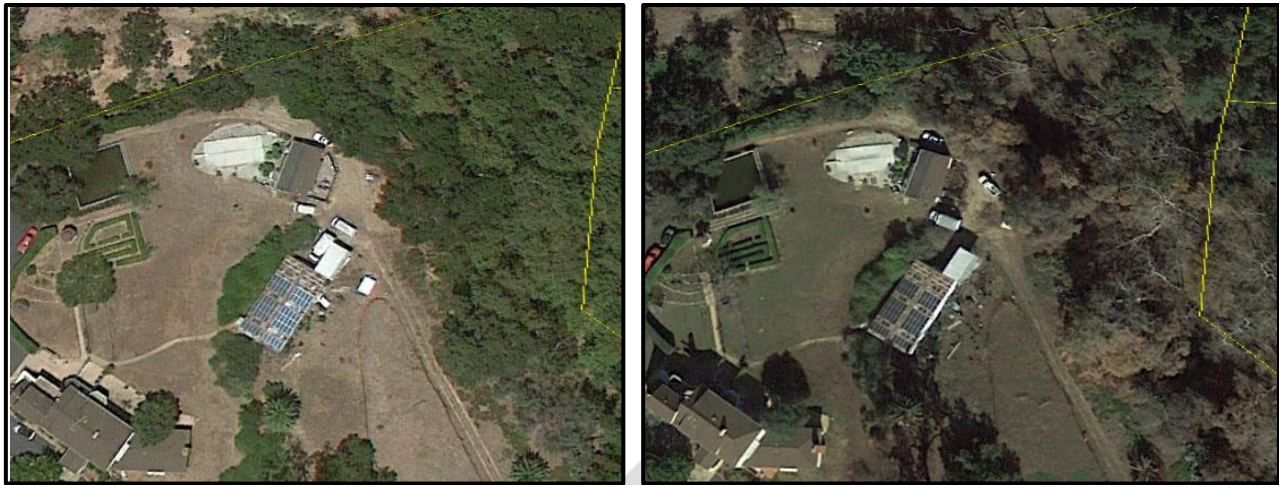
Ashley Road - ADU was destroyed. This does not appear to be the PDU on the property but may have been the original homestead. This structure was built in 1900 and had a combustible roof, single-pane windows, non-combustible exterior siding (stucco or concrete), a wood deck, and unscreened vents. ADU was on flat ground and had less than 5m (16 feet) of defensible space. The ADU sat next to the Cold Spring Creek drainage with considerable riparian vegetation on the eastern side of the ADU and with a driveway separating the ADU from the vegetation. This ADU was likely ignited by embers, as photos show the wooden deck and fence partially consumed and a space underneath the deck. Debris build-up under a deck is common and ignitions from embers can easily occur in this debris. Additionally, there is evidence of debris on the deck that could have easily ignited and then supported ignition of the doors and/or entry through a broken window from fire intensity igniting burnable material within the ADU.

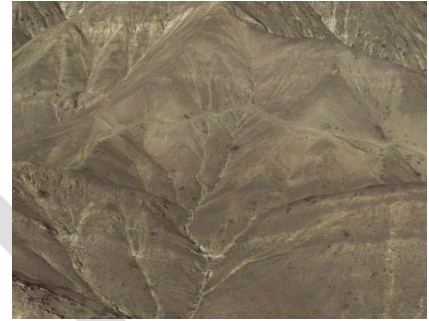
1) While the chaparral ecosystem in the area is primarily comprised of rapid re-sprouters that are fire-adapted, there was minimal re-sprout occurring on the slopes above Montecito. This is unusual, particularly as the area had received winter rains and the timing was such that re-sprouting was anticipated. The team observed entire slope patches with no visible green vegetation and no blackened shrub stumps (See Figure 9). This leads to the conclusion that even the fire-adapted shrub species were so drought-stressed and so much of the area burned at such high severity (with such low soil moisture present) that the fire induced widespread mortality of plants.

Figure 7 Aerial view of a mid-slope location above Montecito where some of the most intense fire activity occurred.

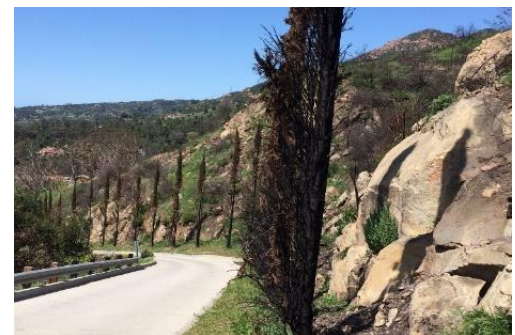
4) Cypress is another non-native tree that is widely used for landscaping and screening in the Montecito area. In contrast to the fire-resistance we observed in some eucalyptus, cypresses were consistently consumed throughout the impact area; often well away from the fire edge. This suggests that cypress were highly susceptible fuels to the ember showers observed during the Thomas Fire. Further, many of the damaged PDUs and ADUs had burned cypress trees as the source of the flame damage, suggesting that this species is a very poor choice for landscaping within the defensible space zone.

Figure 8 Cypress trees burned during Thomas Fire

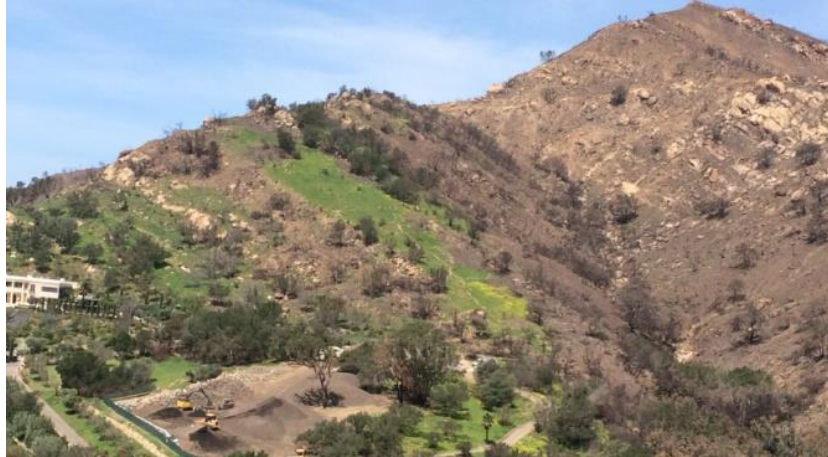
- 5) By contrast to the areas above Montecito where high severity fire completely consumed all vegetation across large slope patches, areas where some fuel reduction had occurred prior to the Thomas Fire had lower severity fire effects. Across much of the uppermost built area of Montecito, both property-owners and the District had conducted thinning and fuel reduction activities (see Figure 11). Within treated areas, the research team observed a much higher rate of tree and shrub survival, as evidenced by unscorched crowns and new growth post-fire.

Figure 9 Looking west across the San Ysidro drainage to an area upslope of the San Ysidro Ranch. The right side of the photo shows where no thinning had occurred, and vegetation burned at high severity. By contrast, as the fire moved into the thinned area (left side of photo), the reduction of fuel reduced the intensity from a crown fire in the chaparral to a surface fire, reducing shrub scorch and mortality, thereby facilitating more rapid regeneration of understory grasses and robs due to the lower intensity.
