A DEFENSIBLE COMMUNITY?

A Retrospective Study of
Montecito Fire Protection
District's Wildland Fire
Program during the 2017
Thomas Fire

October 9, 2018

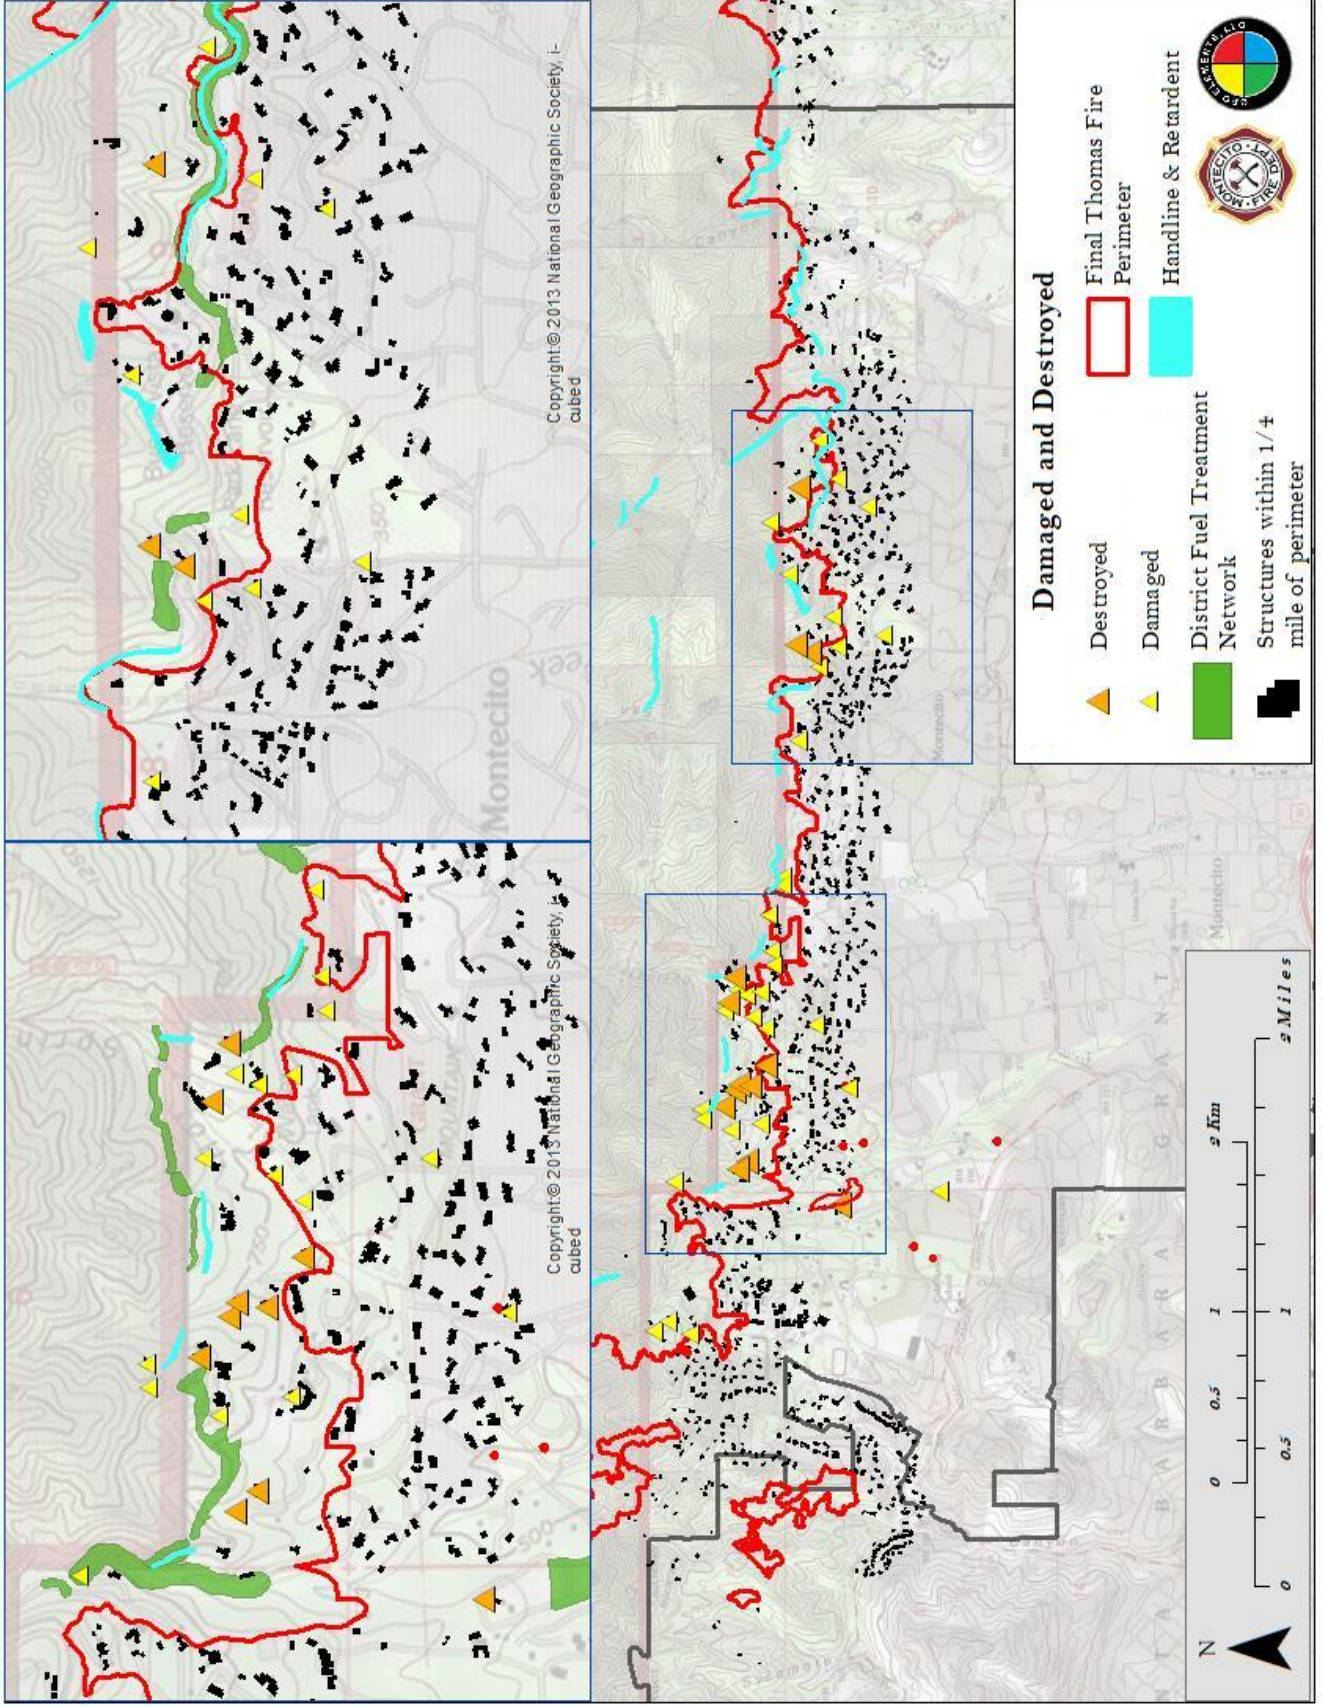
Figure 8 PDUs and ADUs Damaged and Destroyed Map

Geo Elements staff confirmed seven primary dwelling units (PDUs) destroyed, seven additional dwelling units (ADUs) destroyed, and 37 total addresses with some level of damage or destruction (many addresses had more than one structure damaged), including destroyed outbuildings and trailers, and damage to gates, burned landscaping, and other structures (See Figure 8 and tables 2 and 3). Additionally, the roof of one of the holding reservoirs for the Montecito Water District was destroyed. While damage was quantified as percent damaged in six classes (1 - 9%, 10 - 25%, 26 - 50%, 51 - 75%, 76 - 99%, and 100% destroyed), nearly all of the damaged structures in Montecito fell into the two categories at the extremes: 1 - 9% and 100% destroyed.

Secondly, these PDUs and ADUs all had a receptive fuel somewhere immediately adjacent to or as part of the structure. While several of the affected properties had some level of vegetation clearance, none of them met the California Public Resource Code 4291 defensible space standards, which stipulates there is no flammable vegetation or landscaping material within 30 feet of the home's exterior. At most properties, there were trees or bushes adjacent to the structure, a wooden attachment (deck, fence), or exterior flammable material leaning up against the structure.

Finally, it is also notable that two of the PDUs and three of the ADUs destroyed were located below a gap in the Montecito fuel treatment network, just west of Hot Springs Road. This gap was identified by the District's Wildland Fire Specialist as a potential point of weakness in the fuel treatment network prior to the Thomas Fire. Unfortunately, this gap aligned with the primary fire front as it moved into the community on December 16th. All five of these destroyed PDUs and ADUs were surrounded by dense vegetation, with trees overhanging the driveway and homes, and it is likely that these structures were exposed to substantial ember wash, intense heat, and direct flame impingement.

In contrast to the destroyed PDUs and ADUs, most of the damaged PDUs and ADUs were located at addresses where at least some hazard reduction efforts had been undertaken or where the property-owner had developed defensible space. Several properties were accessible and safe for firefighters to engage in structure defense or fire following tactics.

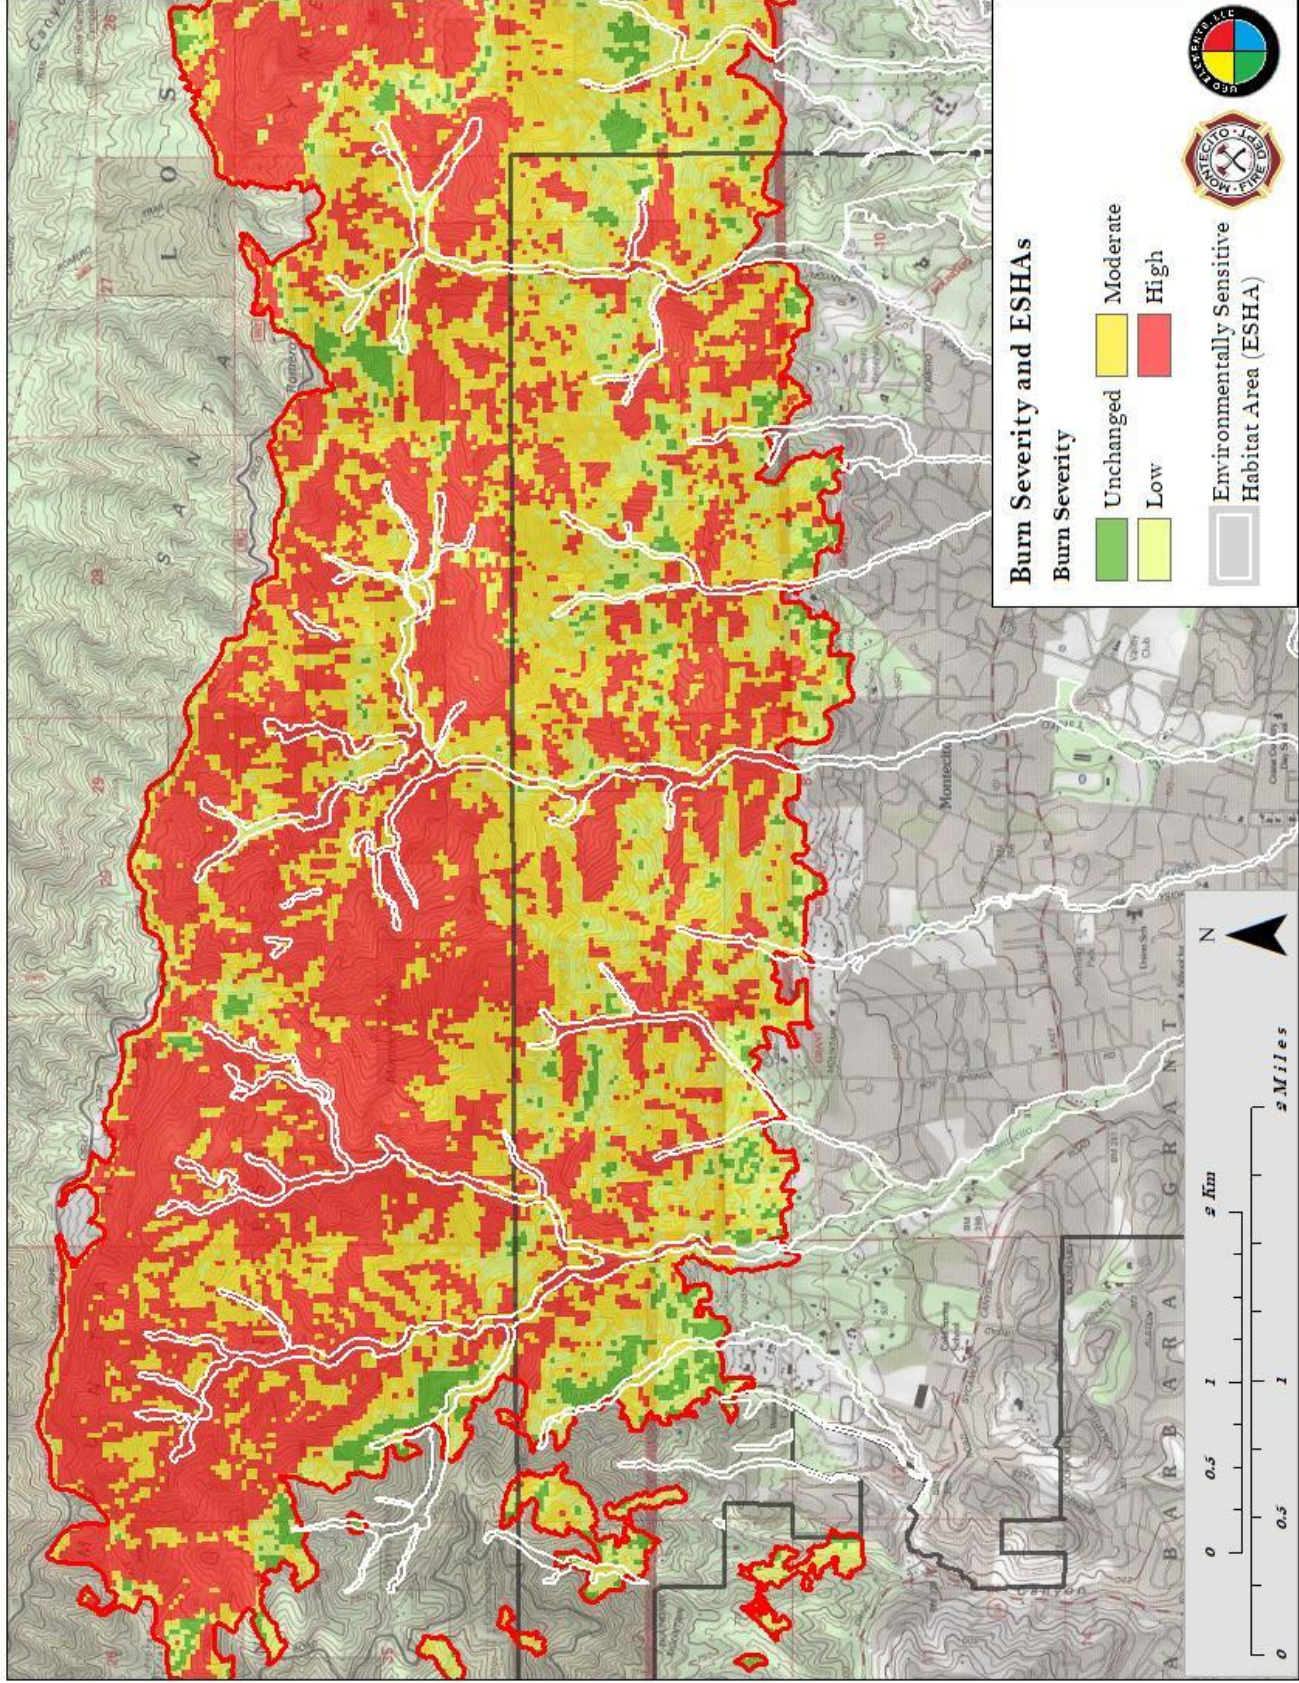
Figure 12 Burned area severity and ESHAs Map

ESHAs occur primarily in the riparian zones along the drainages that bisect the District. Burn severity mapping for the Thomas Fire and post-fire high-resolution satellite imagery indicate that the ESHAs burned predominantly at moderate to high severity, suggesting that habitat is likely compromised until sufficient regeneration and restoration occurs (See Figure 14).

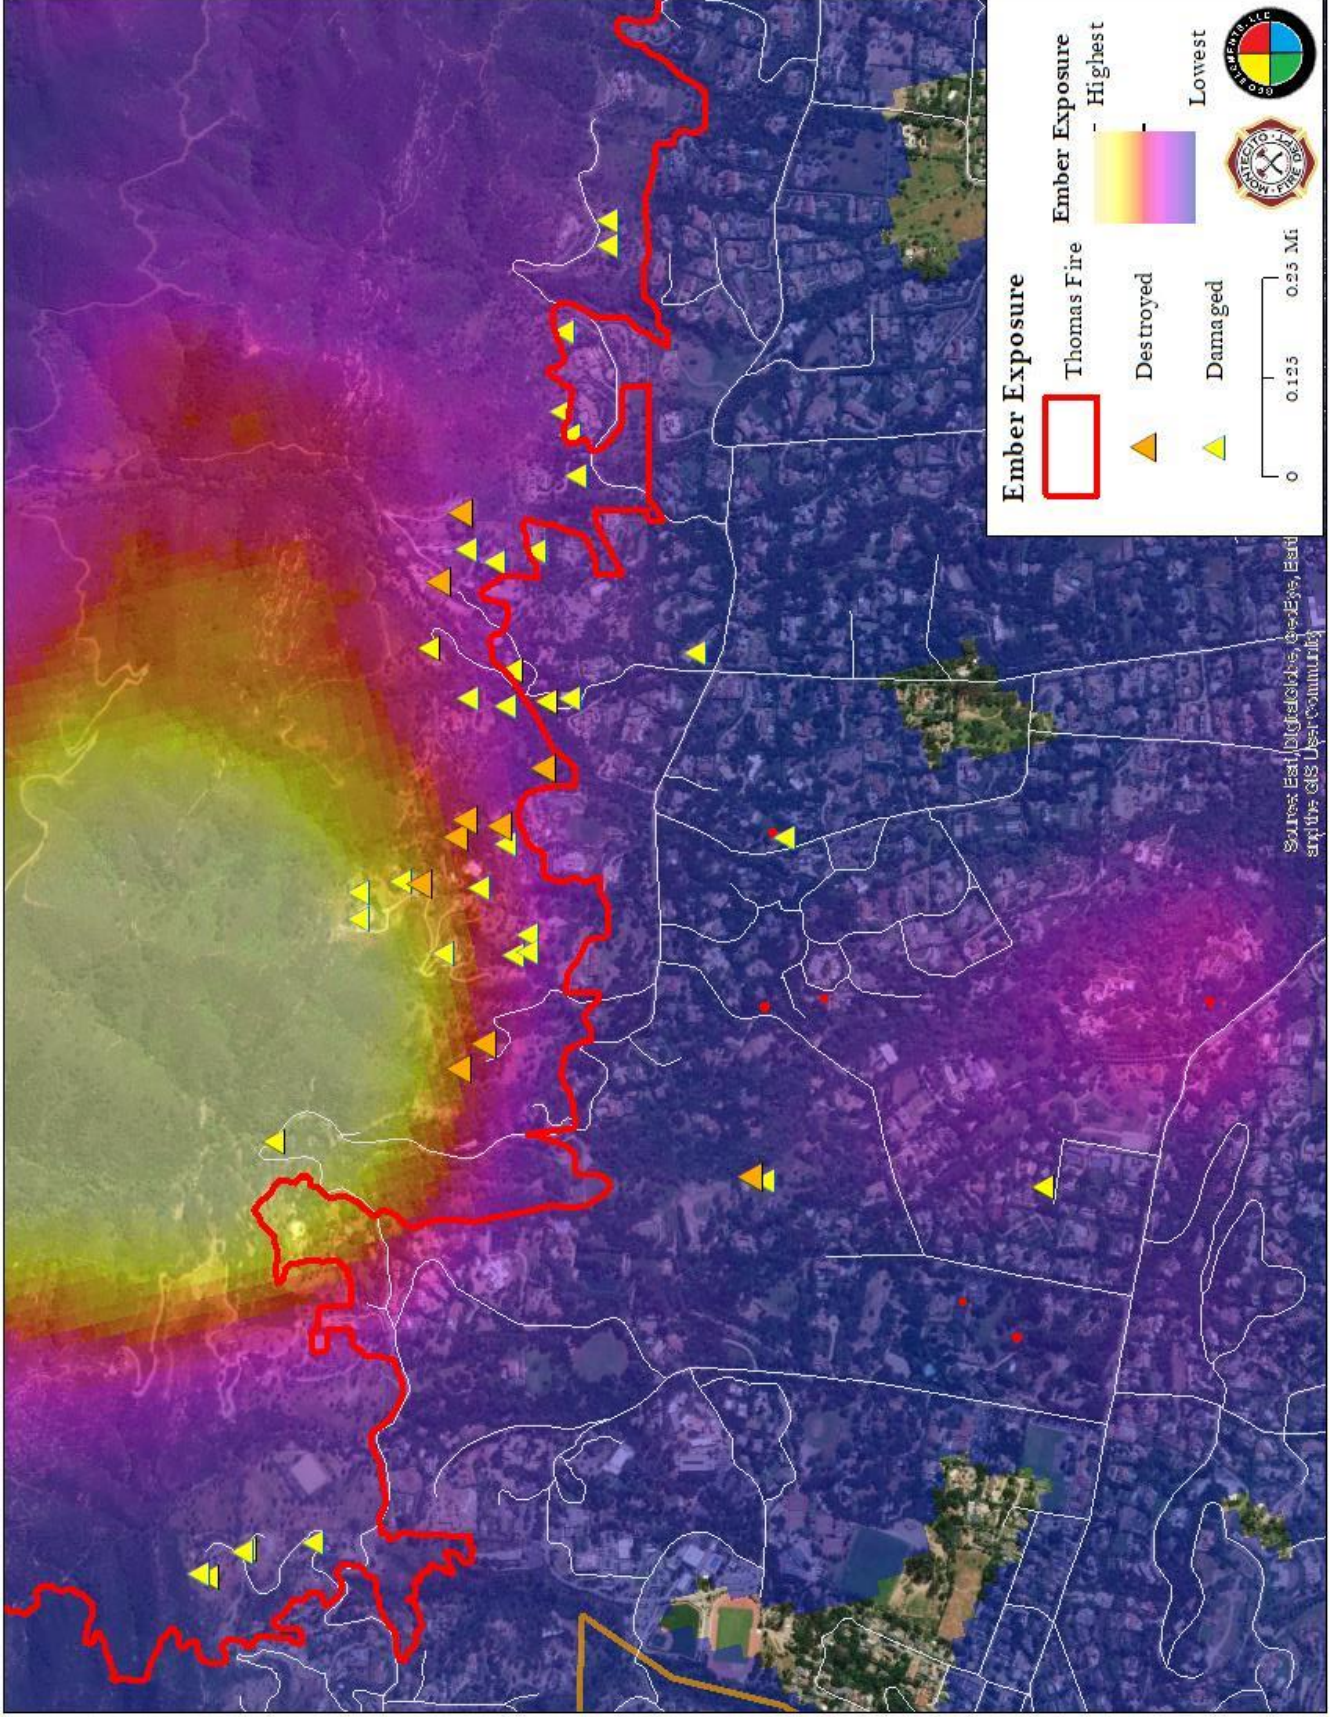
Figure 14 2016 CWPP Ember Exposure Zone Map

particularly as it is assumed that most damage to structures was associated with ember ignitions, and all damage observed outside/south of the fire perimeter was ember-ignited. The ember exposure model from the CWPP predicted that the highest density of embers would be received in a few key areas given a north wind of 60-mph. For the eastern half of Montecito, the Sundowner wind was not a factor, with a backing fire dominating fire behavior as the Thomas Fire intersected Montecito. Across the western portion of the community, however, the model was very accurate in indicating where the highest damage levels would be. One of the predicted peak ember density locations was the area between the Cold Spring and Hot Springs drainages, which is also where the highest density of destroyed and damaged structures occurred (See Figure 16).
